188 East 70th Street Condominium Association Board of Managers Newsletter

Project, Projects, Projects

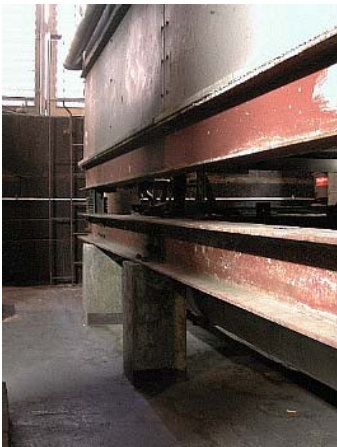
The cooling tower contains thousands of gallons of water. The floor was never waterproofed. This must be done to protect against flooding of units below.

4. Cooling tower floors must be waterproofed. Thousands of gallons of water are contained in the cooling towers and units could be flooded should a catastrophic failure of the system ever occur.
