188 E 70

Report on 188 East 70th Street

March 7, 2001

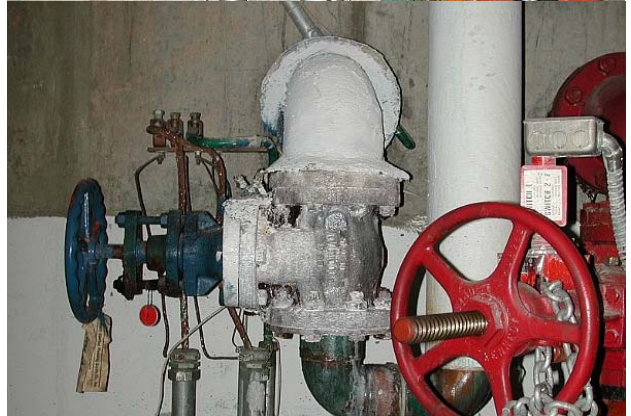
In an attempt to trace the source of leaks, Eugene discovered this valve. It had not had any maintenance for many years and did not even appear on the Rand report commissioned to assess the physical plant. The advanced state of the corrosion and neglect made it a very serious potential disaster.

Main water shut-off valve. Top photo the serious state of corrosion. Above, the valve has been insulated and fully checked and cleaned. All valves in this room were serviced.

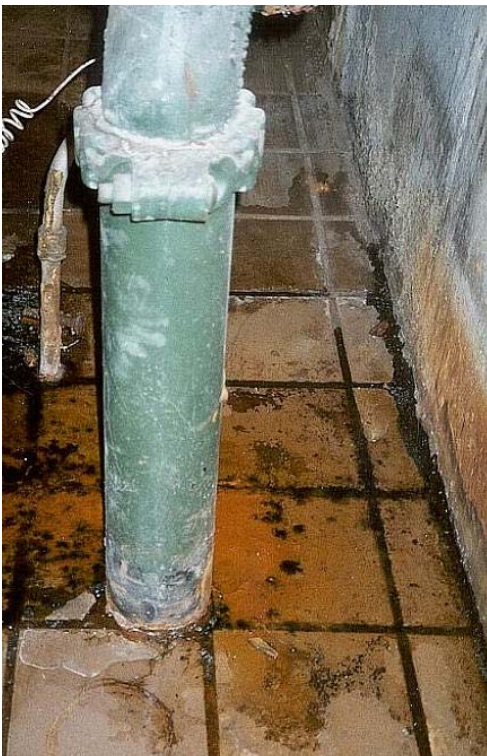
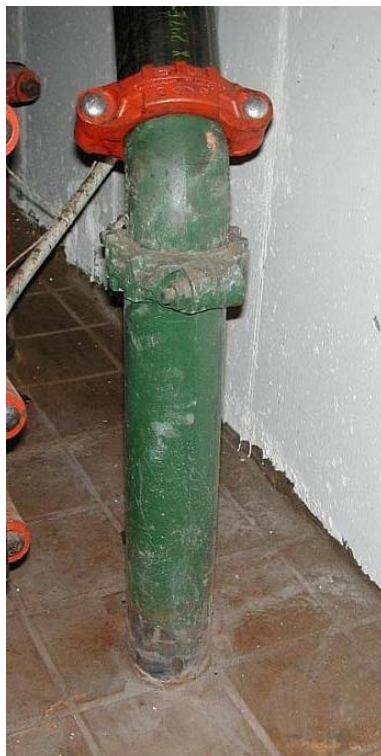
Above left you see the standing water and mold indicating serious long-term neglect. The water leaks were caused by badly maintained valves. Above right you see the clean and dry floor now that the valves have been repacked. This is basic but important maintenance.

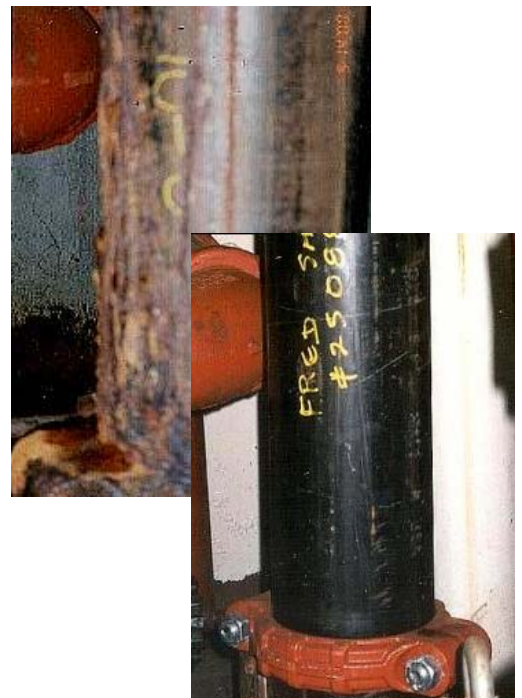
Below left shows the state of decay on one of the main sprinkler lines. This line is connected to a 4,000 gallon tank on the roof. A rupture in this joint might have caused a very serious flood. The repaired pipe and new joints are shown below right.

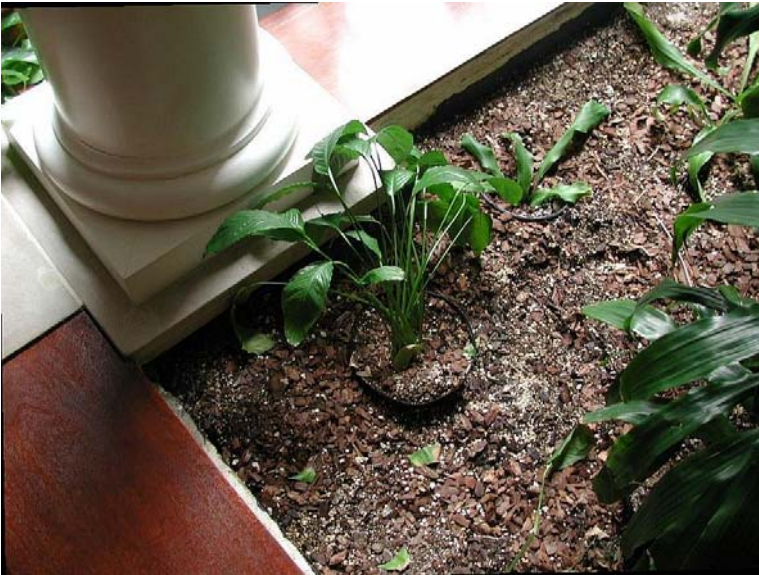
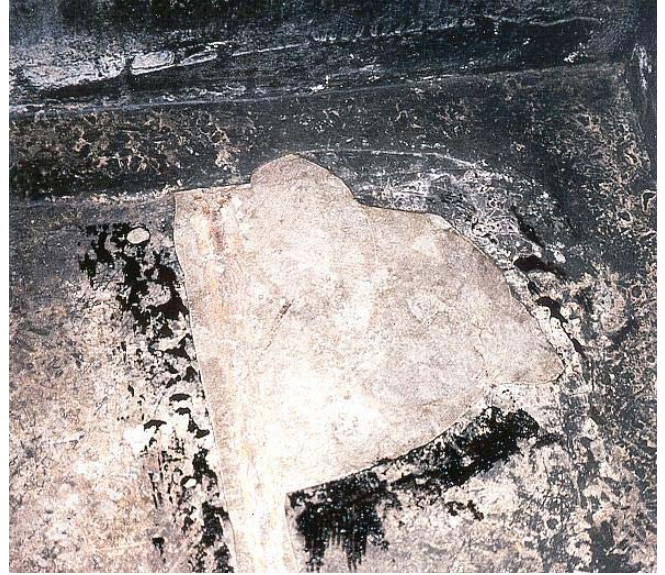
Leaks from the atrium planters into the commercial space below were chronic. Eugene proceeded to completely remove the plants and soil from the planters and clean them completely. You see below that the liners had not been tarred properly and raw concrete was exposed to water.

The opportunity for leaks was obvious when exposed. The planters have since been completely renovated and are now operating as designed.

At far left you see the gap in the brick wall above the planters at the entrance to the playroom. This gap had not been filled in since the building was originally constructed.

This gap was the cause of water leaking into the atrium from the skylight above.

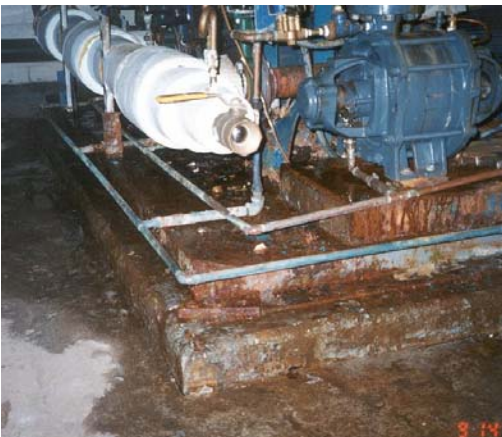
Dangerous conditions were found in the pump room. Below left, you see the corrosion and leaking around the pumps for building water supply. Even more serious was the condition of the pumps themselves due to long-term neglect of proper maintenance. Because he is a professional engineer, Eugene was able to do much of the major repair in-house and saved the building approximately \$5,000.00. You see the results is below.

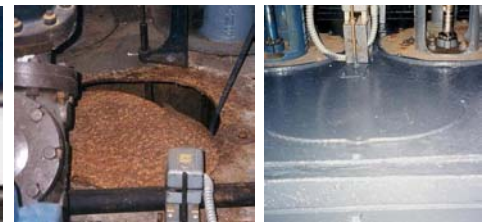
Above you see that the sewer sump pump was in serious disrepair. The cover was rusted and corroded and the motor compartment was filthy. It has been cleaned and painted.

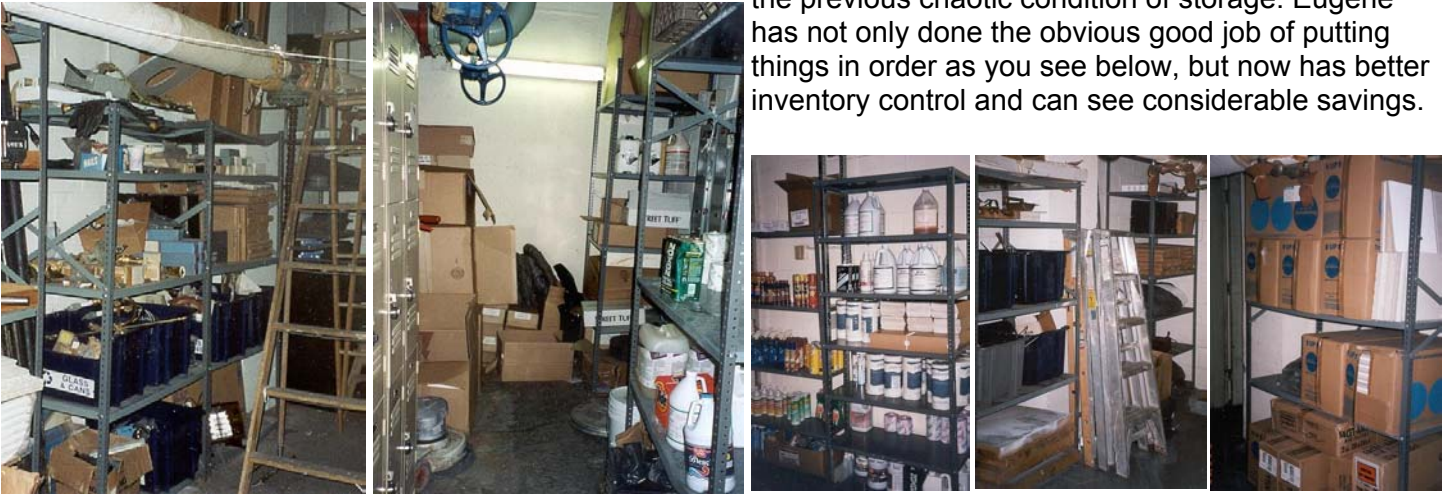
Supplies and maintenance materials were stored in a hopeless jumble. Inventory was not kept so it was impossible to know if supplies were just being used or perhaps disappearing. The large photos at left show the previous chaotic condition of storage. Eugene has not only done the obvious good job of putting things in order as you see below, but now has better inventory control and can see considerable savings.

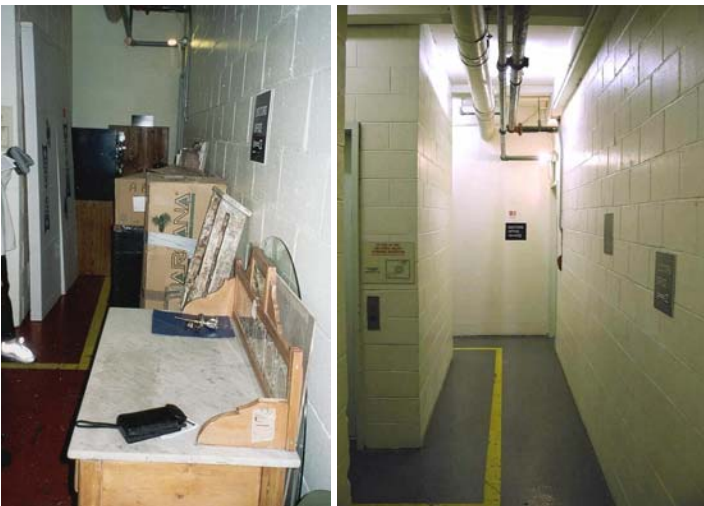
Lack of proper supervision and control of the physical space in your building is not just a matter of esthetics and opinion. It is a serious matter of basic fire safety.

The current board, after considerable struggle to get cooperation, forced the previous superintendent to arrange for removal of personal property. It has now been made certain that halls are always clear and clean.

Storing materials in the wrong places can cause severe obstruction to emergency crews and be a general fire hazard.

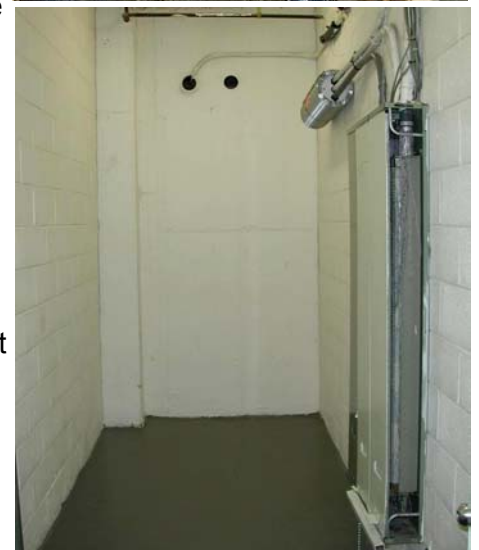
At top is the incredible mess made of the telephone room. It is unlawful and a fire hazard for anything to be stored here. Above is the condition today.

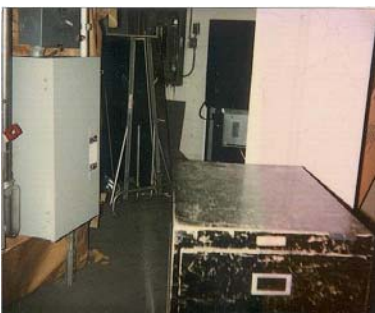
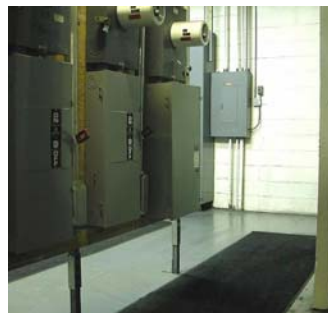
This is the electric room. Furniture and trunks and other items were stored here. By law, this room must be free of any unauthorized gear.
