# 188 E 70

## Report on HVAC Major Move & Routine Maintenance

## Report on Water Heaters State-of-the-Art New System

## Report on Lobby Clouds Restoration

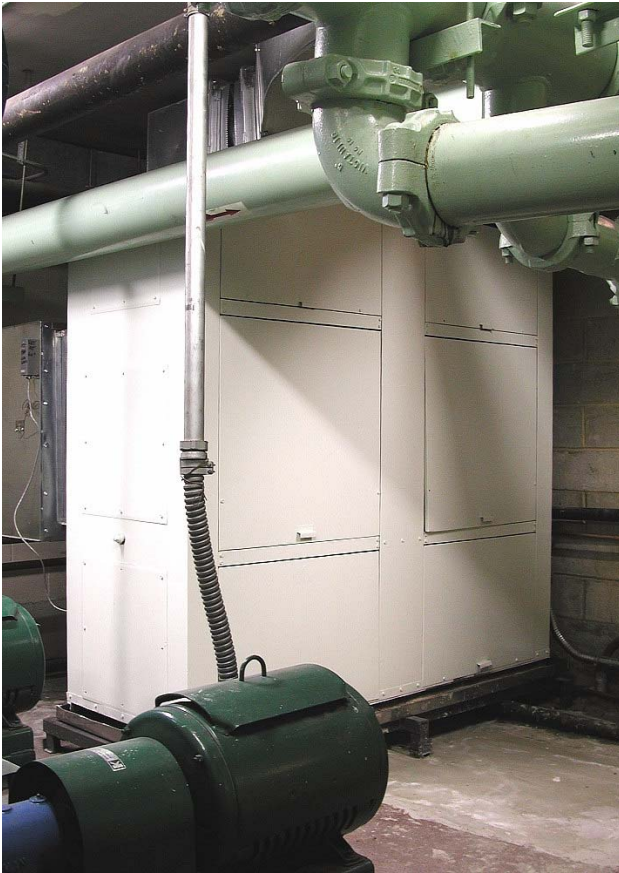
A major advance in the HVAC room has been made. This unit (photo left) had been originally placed directly on the floor where it could not be properly drained. The unit has now been raised for drainage and rotated 90° allowing full access to front and back for maintenance.

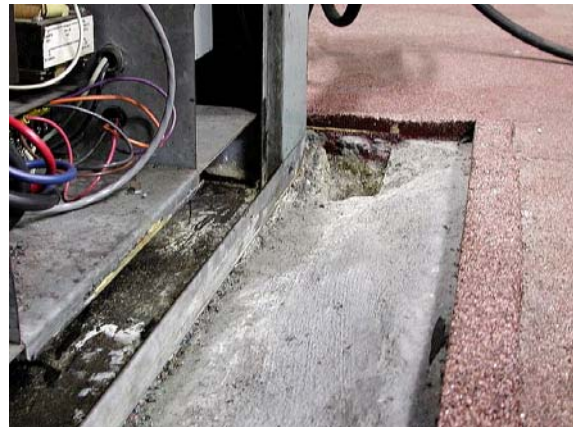
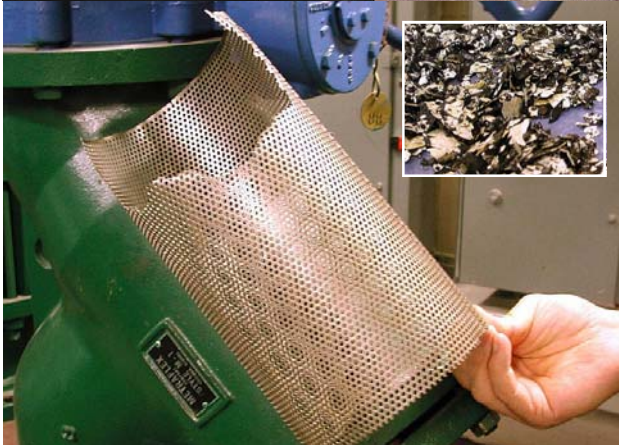
This screen in one of the main water circulation systems for the HVAC system was found to be broken. Inset shows debris that had accumulated in screen.

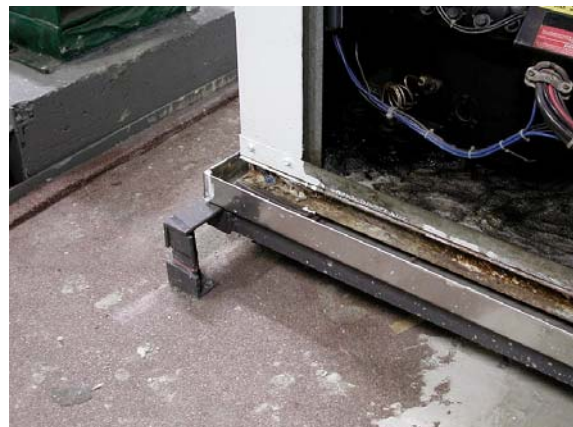
The original installation made it impossible to drain the system (top), the new installation places the unit in a pan that can be drained easily (above).

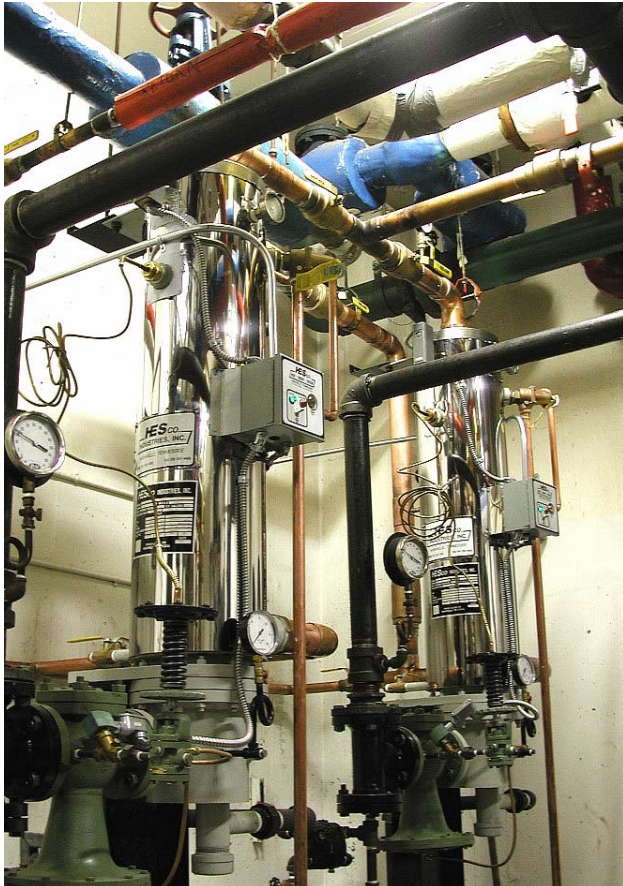
The water heating system is now an all stainless steel, state-of-the-art marvel of high-tech efficiency and miniaturization. The new units (left) take up a fraction of the space required by the old units and produce hot water much more efficiently. Better maintenance could have saved the older units, but they had deteriorated beyond the point that repair was practical.

The installation of the new stainless steel system was the best way to cure the problem for good.

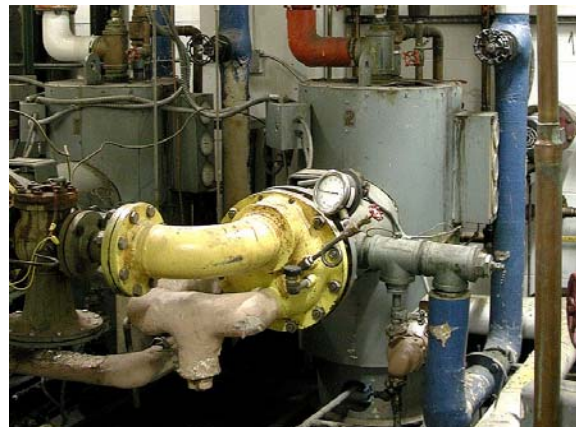
The old water heaters (right top) took up considerably more room than the new ones (above).

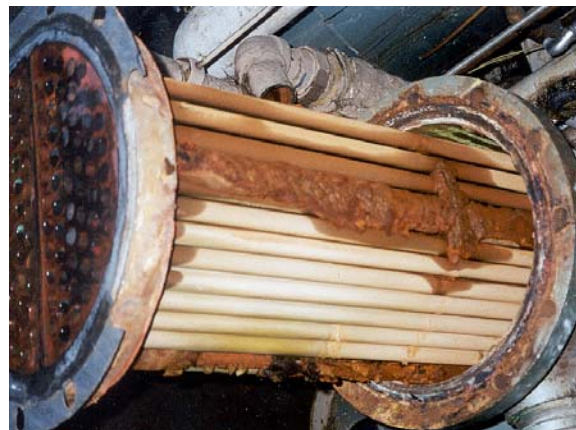
The building had been plagued by brown water problems for years. Until recently, the state of the water heater cores had never been investigated adequately. When the cores were extracted it was obvious (right bottom) that this was the source of some, if not all of the problem. Consideration was given to repair of the existing units, but complete replacement was the only course that could definitively remove the possibility of this kind of deterioration in the future.

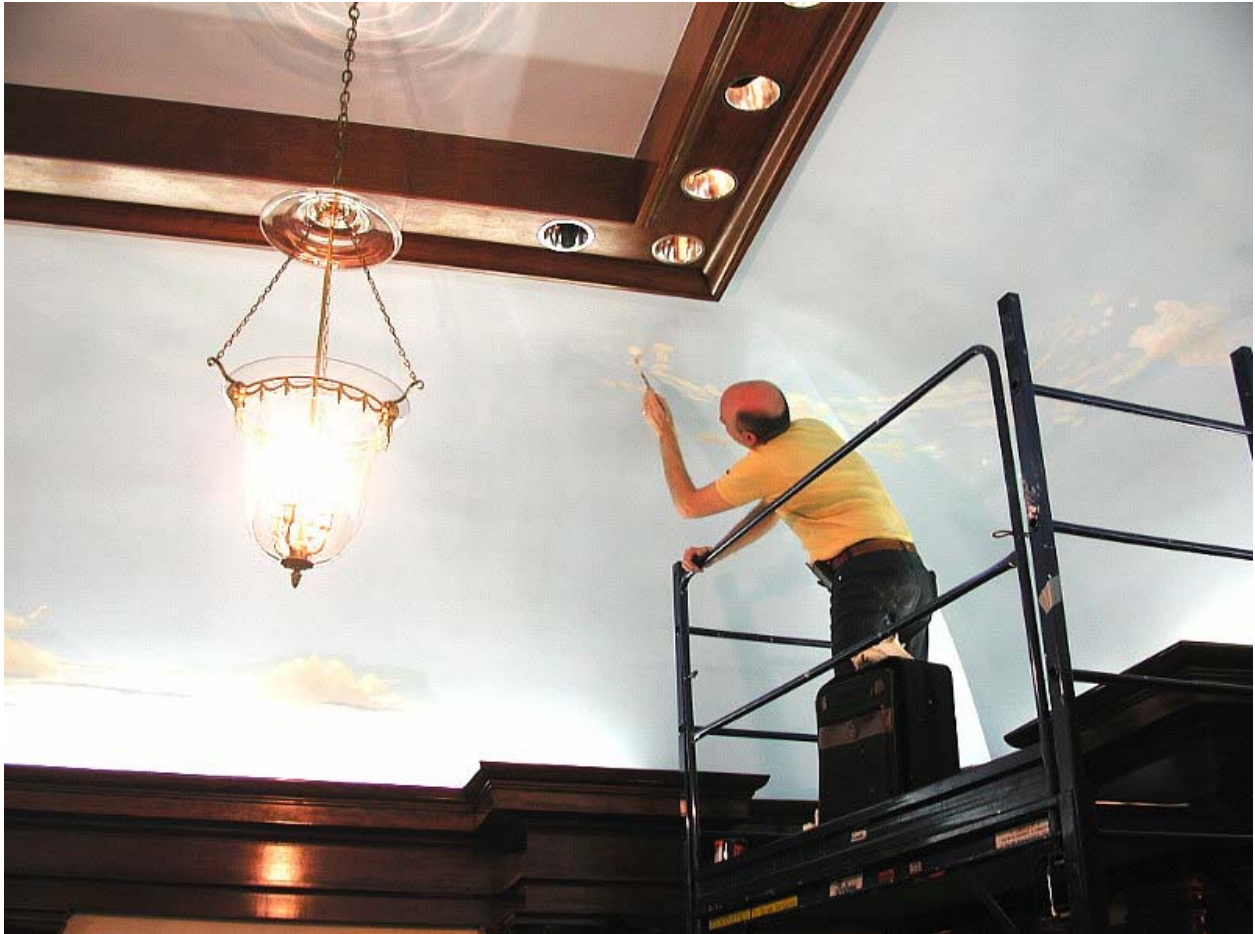
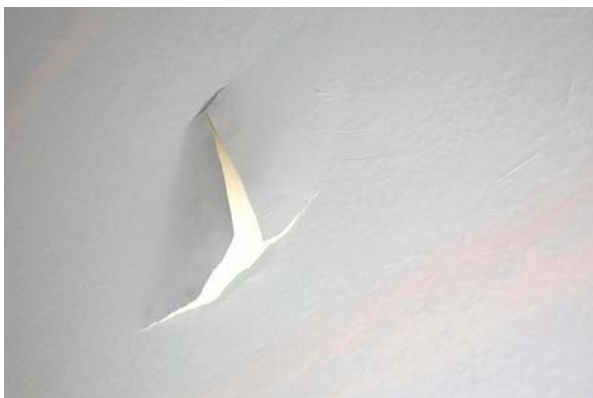
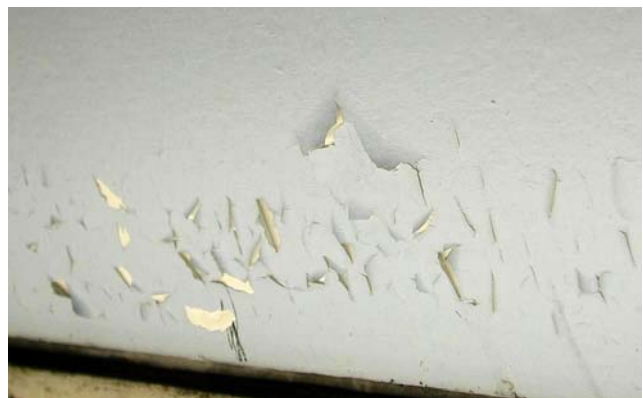
You may have noticed the scaffolding in the lobby supporting our cloud restoration project. The peeling and general deterioration had to be addressed.
