### Where Do Leaks Come From?

## Cooling Tower Renovation

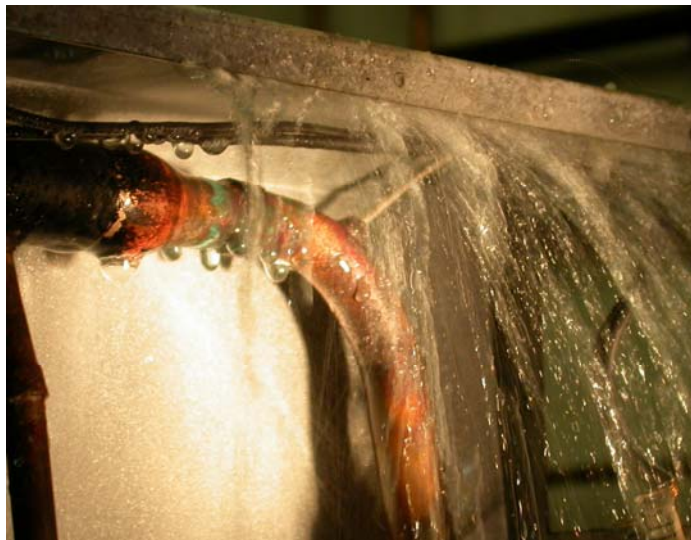
The failure a copper solder joint in an HVAC unit illustrates the fact that water damage is often the result of accidental failure of otherwise well-maintained systems. This unit is one of many hundreds in the building and the only one ever to have this kind of failure. There is no one to blame for one random failure and the cost of replacing all HVAC units because of this one failure would be unacceptable. This is why you need homeowner's insurance.

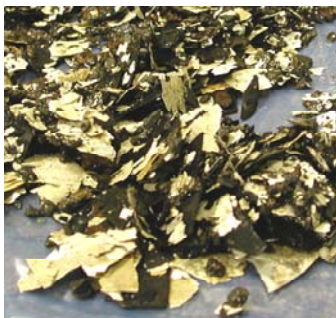
These paint chips came from the improperly painted cooling tower. It has taken three years, but they are now almost completely flushed from the system.

The building staff discovered the interior walls of the tower had been incorrectly painted with ordinary paint a number of years before.

Over time, the paint began to flake off and get flushed into the cooling water system.

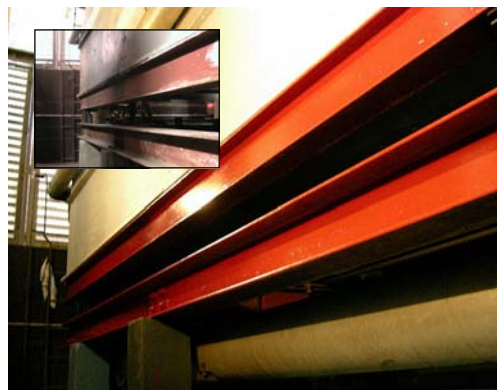
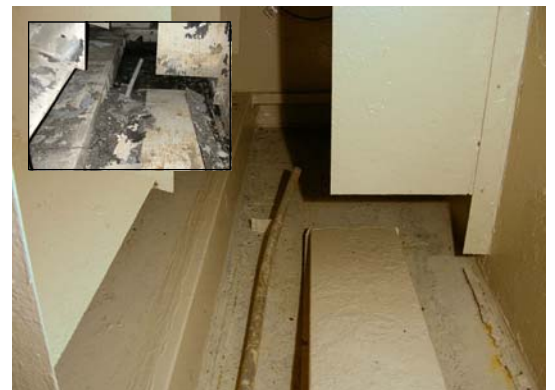
Above left, the exterior of the cooling tower as it appears now with inset photos showing the previous condition. Above right, interior of the cooling tower after repainting with proper paint. Inset photo shows the peeling paint discovered to be the source of the debris in the cooling water system.

Below are photographs of the new interior and exterior paint on the cooling tower. The inset photos show the state of the unit before renovation.

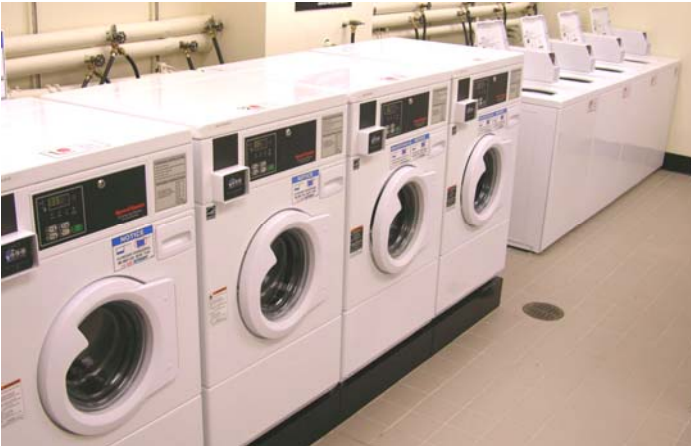
To renew the contract, our current vendor had to compete with two others interested in the concession. The winning bid included a waterproofed floor, new tile, new ceiling and lighting as well as brand new machines.

The floor was waterproofed to assure that our newly restored cloud ceiling in the lobby would not be in danger. All new tile was laid and the ceiling and lighting were replaced as well.

The laundry equipment is completely new. We now have large capacity front loading machines as well as top loading machines. Brand new dryers and a second vending machine to add funds to the machine credit card.

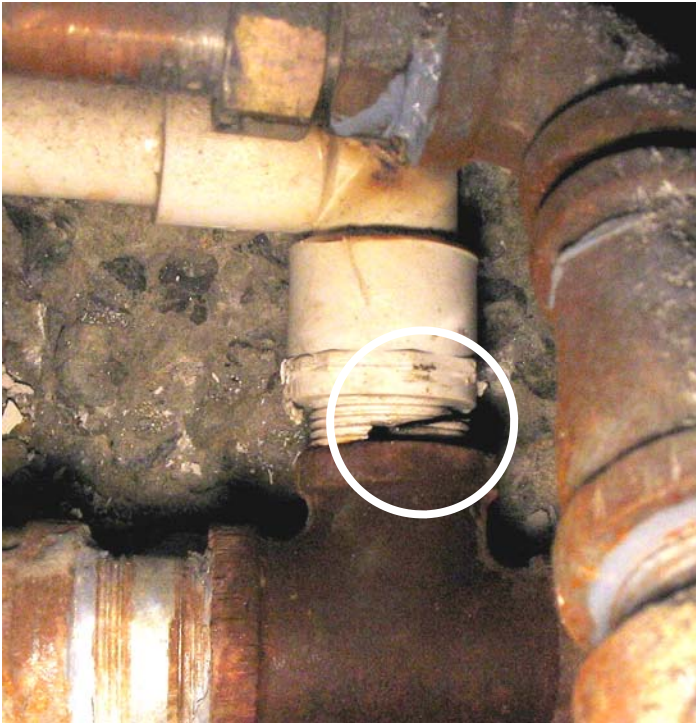
The plastic HVAC drain pipe was connected to a metal pipe. For some reason, the plastic pipe cracked and broke causing a leak whenever the unit created condensate. This crack could not be repaired since the unit owner would not allow access. The leak was stopped temporarily by shutting the unit down. It is now being repaired.

The problem (as you see in the photograph) was not in the HVAC unit, but in the wall where the plastic drain pipe is connected to the building drain lines.

The broken pipe is being replaced since we now have access to the unit while it is being redecorated.

An agreement was reached that the owner would not use that HVAC unit at all and that solved the immediate problem of the leak without actually fixing the failure.

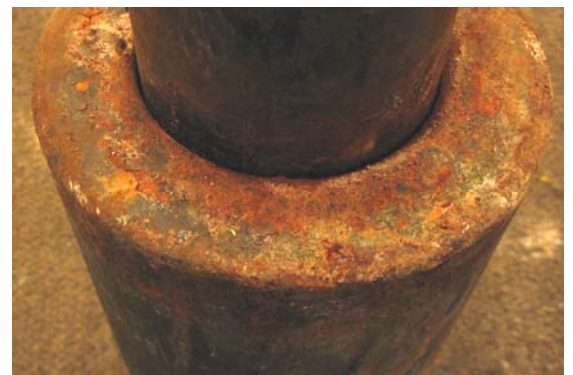
Another case shows that logic can't always help: A leak was discovered on the 11th floor, the wall above the leak was opened and the pipe was indeed wet, but the source of the leak was not there. There was no other way to find the source of the leak but to open the wall for inspection on every floor above the leak and inspect the pipe. we got to the 23rd floor and found that an expansion joint was the source of the leak and the joint was repaired.

This is the actual expansion joint described in the story at left. These joints are essential in long pipe strings. They have internal rings designed to keep water from escaping. However, it is a mechanical device and like any other, has the potential for failure.
