# Spring Report 2008

## 188 East 70

188 East 70th Street Condominium Association Board of Managers Newsletter

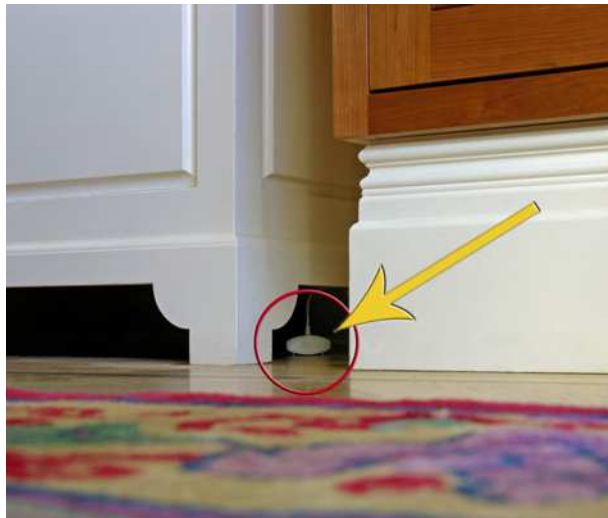
This is the cats-eye view of the sensor. The sensors are wireless and battery operated.

The photo at top right is the brains of the system. It is similar in size to a standard home alarm. The sensors (bottom photo) are about 3" wide and placed at critical points. The sensors are battery powered wireless devices that will run for many years before requiring battery replacement. They are quite small and dozens

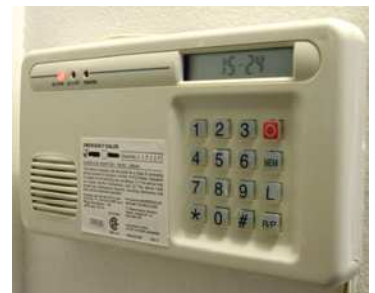
The control unit (above) will call the concierge if a sensor sends a signal. Up to five other phones can be programmed.  
At left is the sensor. When water is detected it sends a signal to the controller. The alarm then goes out.

When the sensor is triggered by the presence of water on the floor, it sends a signal to the control unit. That unit calls the concierge on the phone number that has been dedicated to the water leak warning system. The unit supports up to five other numbers to call so it can warn you as well.

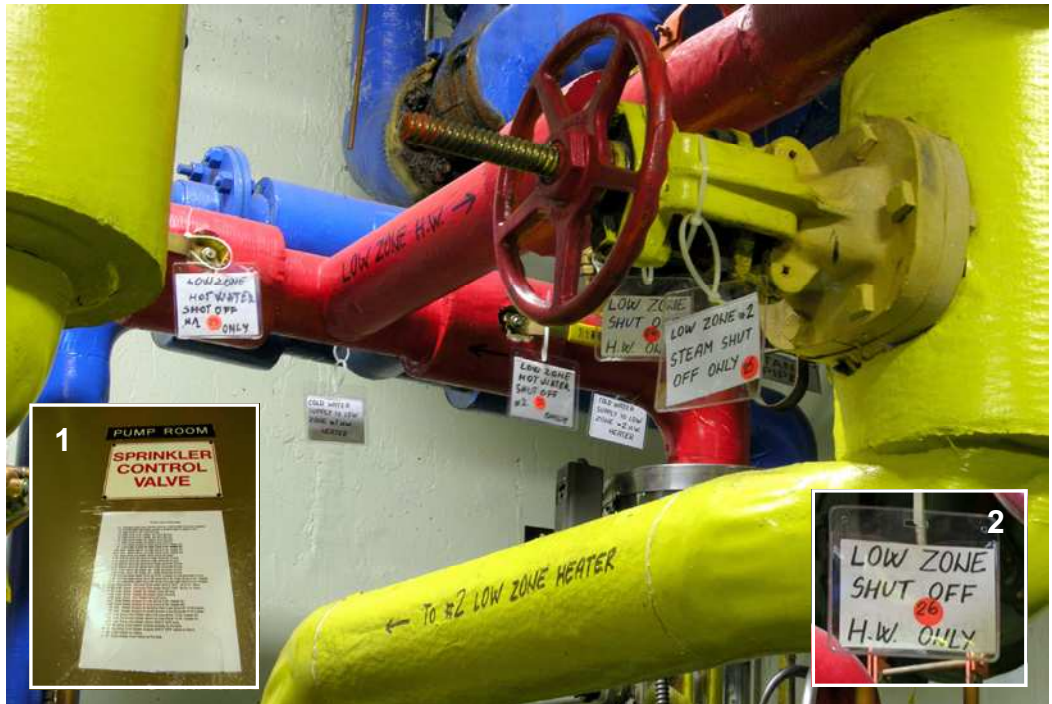
The newly tagged, numbered and painted valves and pipes make it much easier to locate a specific valve. The door to each equipment room has a list of valves (inset #1) and each valve has a description and number (inset #2).

Our resident manager, Eugen Arjoca, and his staff has spent many weeks tracing, tagging and painting the valves and pipes as illustrated in the large photo at right. They created not just a chart, but complete documentation of the valve and pipe system. In addition to the master chart, the door to each equipment room has a detailed list of the valves and systems located in that room. Each valve has a number and a description of its function.

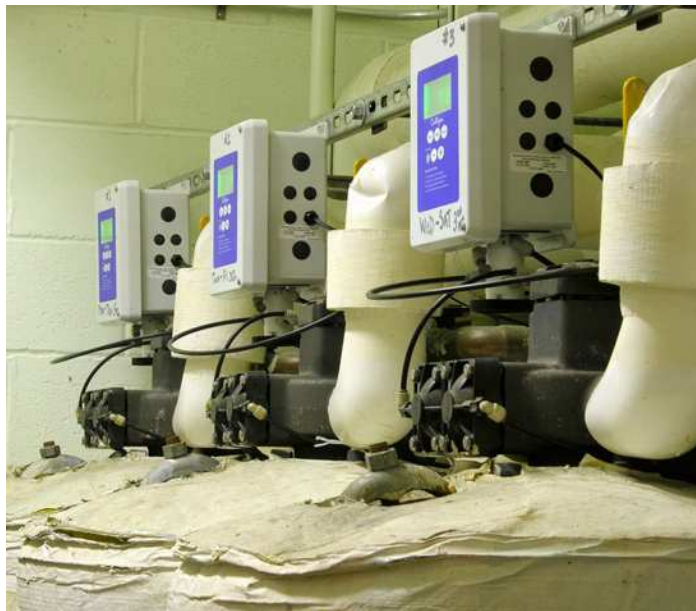
The three tanks in the photograph above filter all the domestic water coming into the building.

The tanks and the insulating jackets were not replaced since they are in excellent condition and fully functional but the quartz filter crystals and the computer controllers are new. The original

controllers had begun to fail and were replaced with digital computerized controllers.

The tanks were emptied and flushed and filled with new quartz crystals. Complete replacement of the crystals takes place every ten to twelve years.

The controllers automatically flush the system twice a week.
